# NBS SPECIAL PUBLICATION 592

## An Investigation of the Miyagi-ken-oki, Japan, Earthquake of June 12, 1978

On June 12, 1978, a destructive earthquake with Richter magnitude of 7.4 occurred off the east coast of Miyagi Prefecture, Japan. Preliminary estimates by the National Land Agency of Japan indicated that the earthquake caused an equivalent of \$800 million in total damage. There is a cooperative agreement between the governments of the United States and Japan termed the U.S.-Japan Program in Natural Resources (UJNR). Following the earthquake, it was arranged through UJNR that teams of U.S. structural engineers and geologists would visit Miyagi Prefecture and inspect the damage caused by the earthquake. This report assembles the information and collective experiences of the investigation team so as to describe the earthquake and document its effects. Field investigations conducted by geologists and structural engineers are described in detail and some of the implications for seismic resistant design and construction of structures in the United States are also discussed.

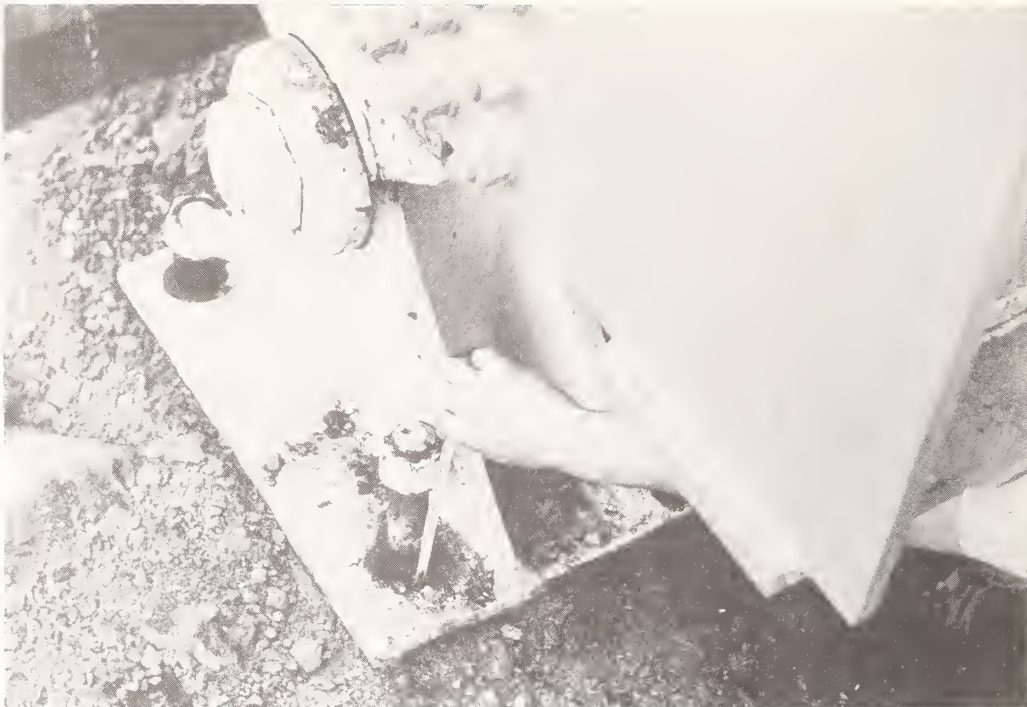
Figure 7.9 Kin-noh Bridge. Extension of anchor bolts at Pier 6. The foreground shows a portion of repaired lower chord truss member.

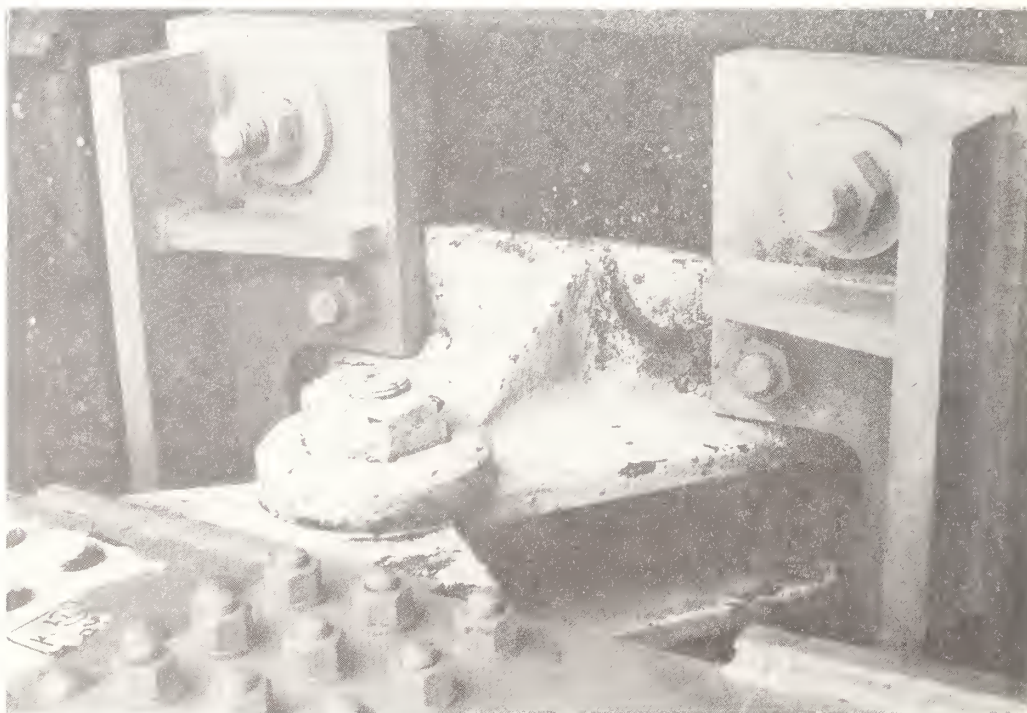
Figure 7.10 Kin-noh Bridge. Bearing restraining device used on the repaired bearing supports of the truss spans. The restrainers were placed before the June 12 event.

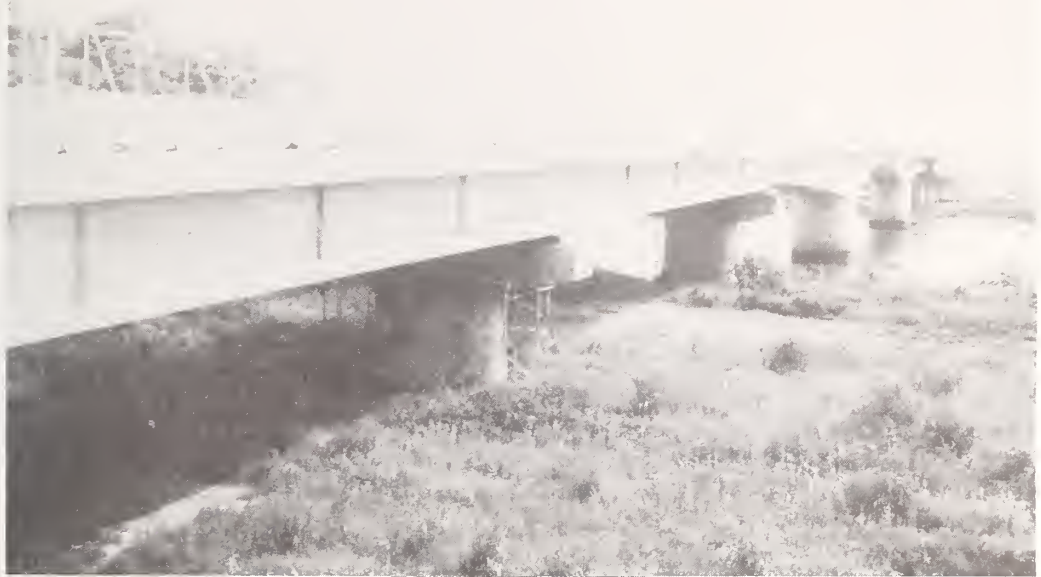
The 10-span Yuriage Bridge (Figures 7.11 - 7.18), constructed in 1962, is located 1.2 km from the mouth of the Natori River on the outskirts of Sendai and is 107 km from the epicenter. It has seven prestressed concrete T-girders each 45 m in length and three main spans which are twin cell, segmentally constructed, post-tensioned concrete box girders, 60, 90, 60 meters in length. The bridge was open to one lane of traffic because of heavy column damage. No damage was reported to the three-span box structure. Excavation at the first pier at the opposite side of the bridge was being done to determine the extent, if any, of foundation damage.

Figure 7.11 General view of the Yuriage Bridge showing the first two columns which were heavily damaged.

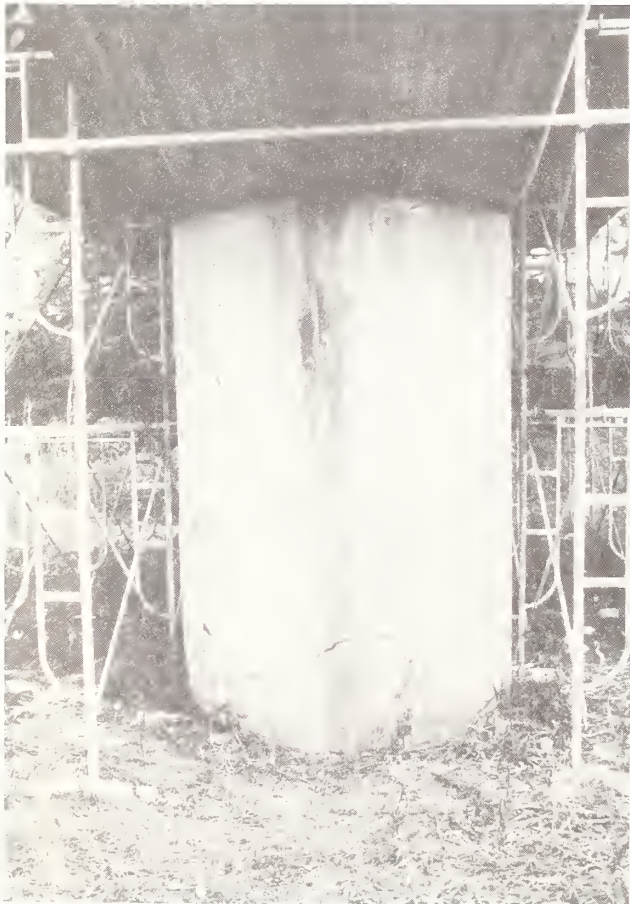
Figure 7.14 Yuriage Bridge. Pier 1, founded on a caisson 19 m deep and 2 m by 4 m in plan, suffered heavy shear cracking. The pier cap was reported to have settled uniformly 5 cm.

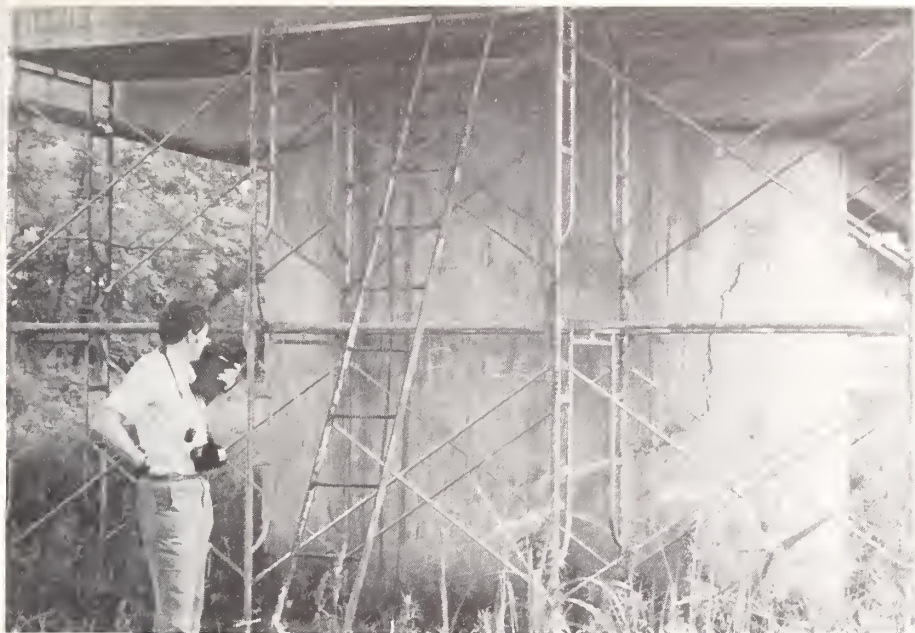
Figure 7.15 Yuriage Bridge. The face of Pier 1 showing severe distress. The plaster of paris patchwork is used to determine if additional pier cracking has occurred.

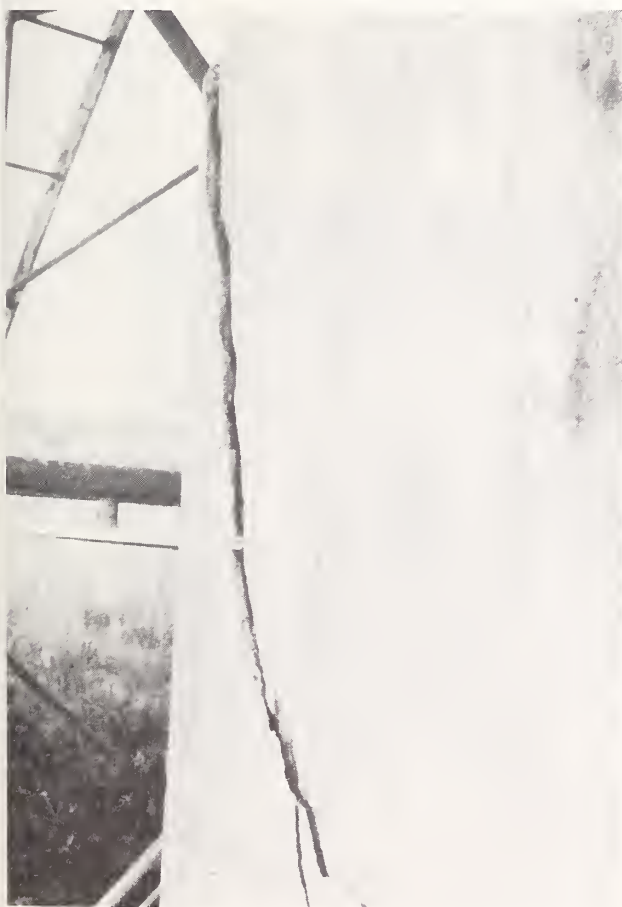
Figure 7.16 Yuriage Bridge. Detail showing 1 cm offset of cracking, indicating torsion in pier.

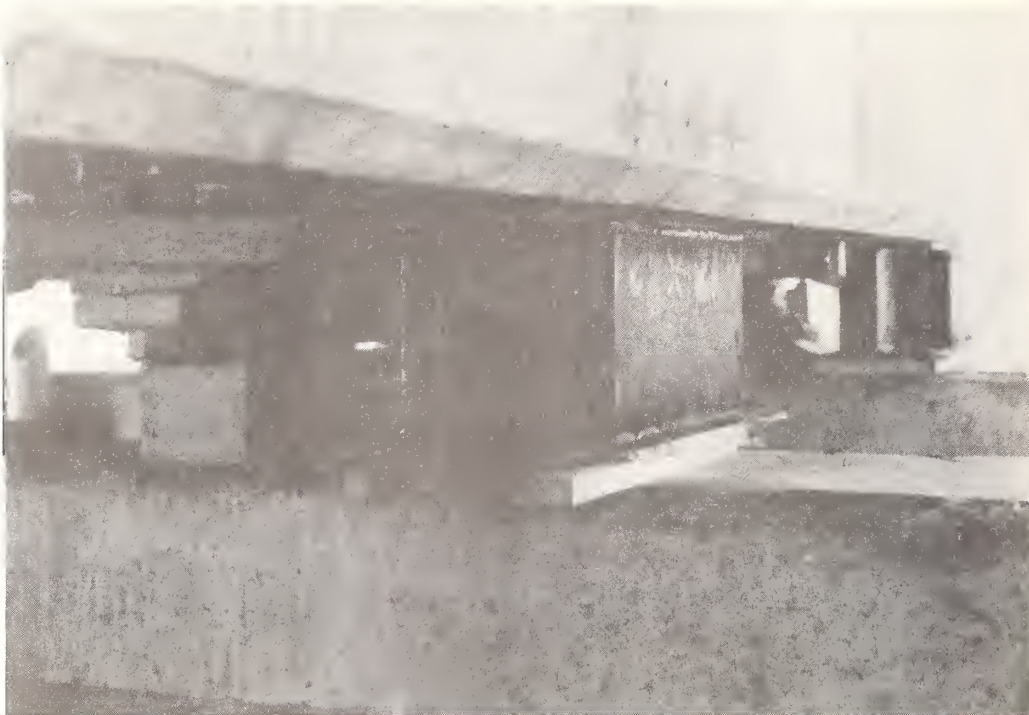
Figure 7.17 Yuriage Bridge. Temporary girder supports at Pier 1. Bearings showed evidence of girder displacement - broken keeper and containment plates.

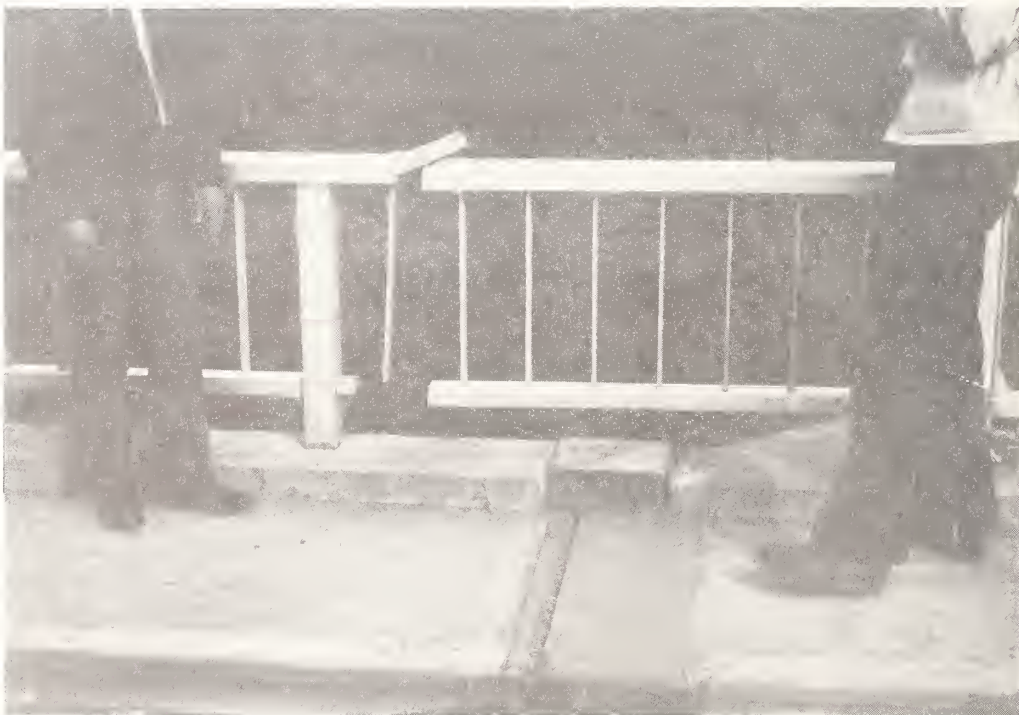
Figure 7.18 Yuriage Bridge. Evidence of 8 cm of longitudinal movement as shown at the handrail expansion joint, Pier 2. However, there was no evidence of damage to the girders or the second pier.

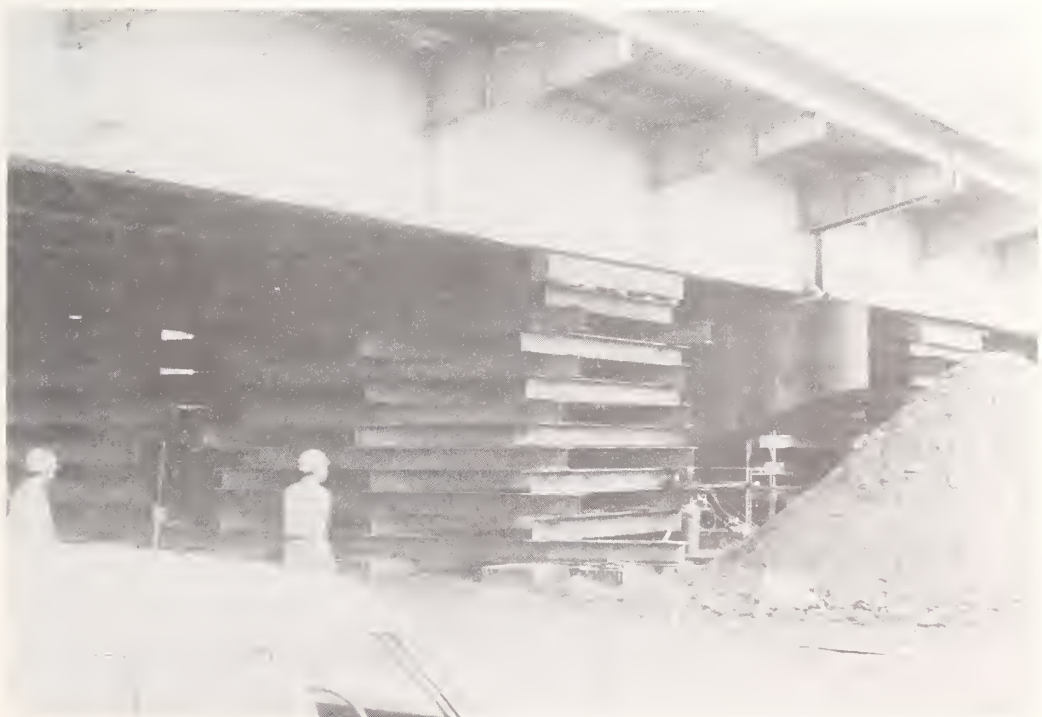
Figure 7.20 Sendai Ohashi Bridge. Temporary cribbing used to support the steel plate girders.

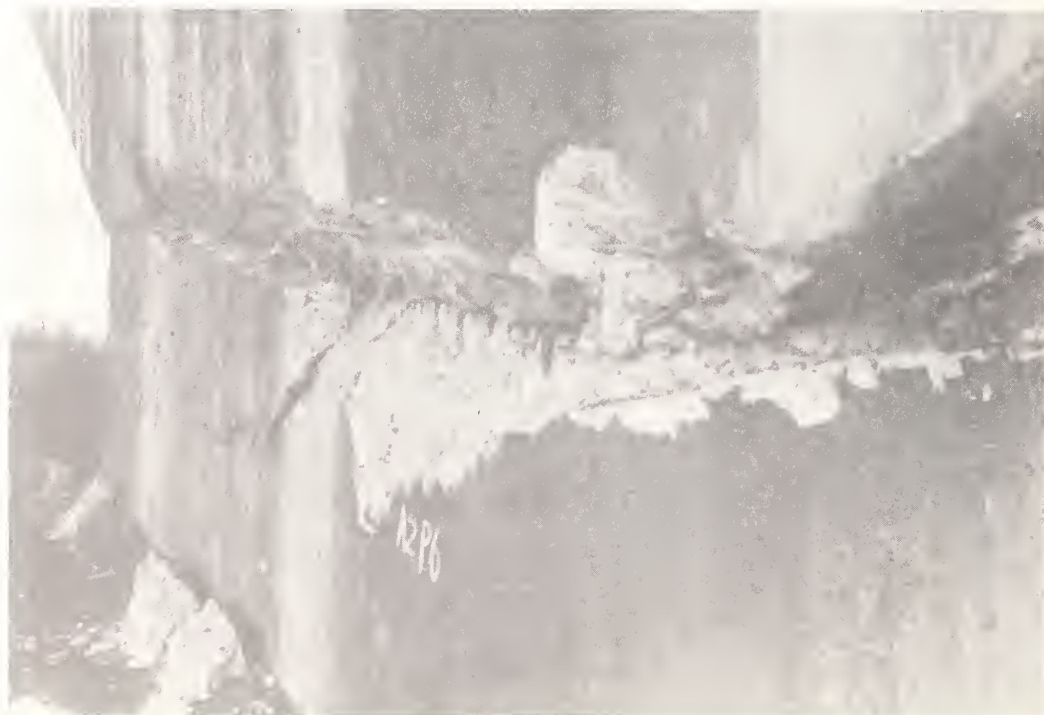
Figure 7.22 Sendai Ohashi Bridge. Typical pier damage at the construction joint between pier and cap. The vertical rebars are buckled across the joint. Significant concrete spalling is evident. Horizontal cracking around the pier was discovered upon excavation of soil around the piers. (Courtesy J.M.O.C.)

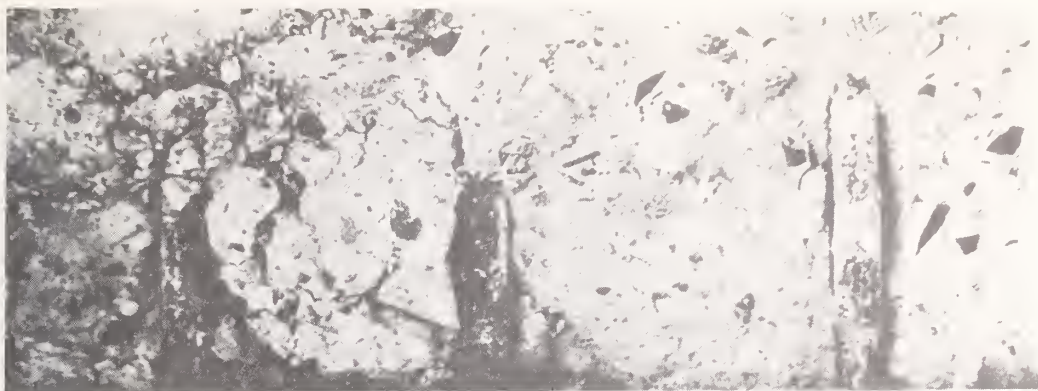
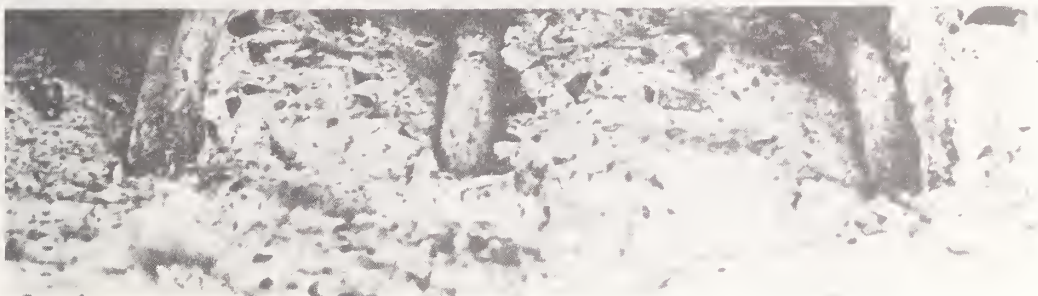
Figure 7.23 Sendai Ohashi Bridge. Detail showing buckled vertical rebar at the construction joint. Strong motion records in Sendai indicated approximately 100 gal. vertical accelerations. (Courtesy J.M.O.C.)

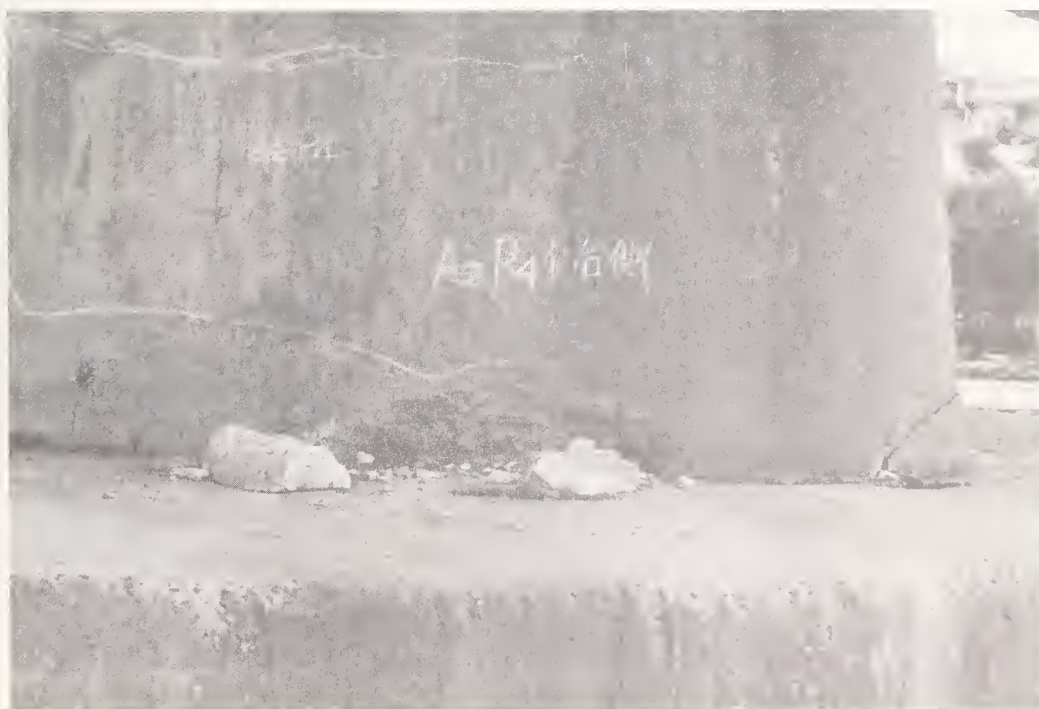
Figure 7.24 Sendai Ohashi Bridge. Typical damage to the base of a pier before repair.

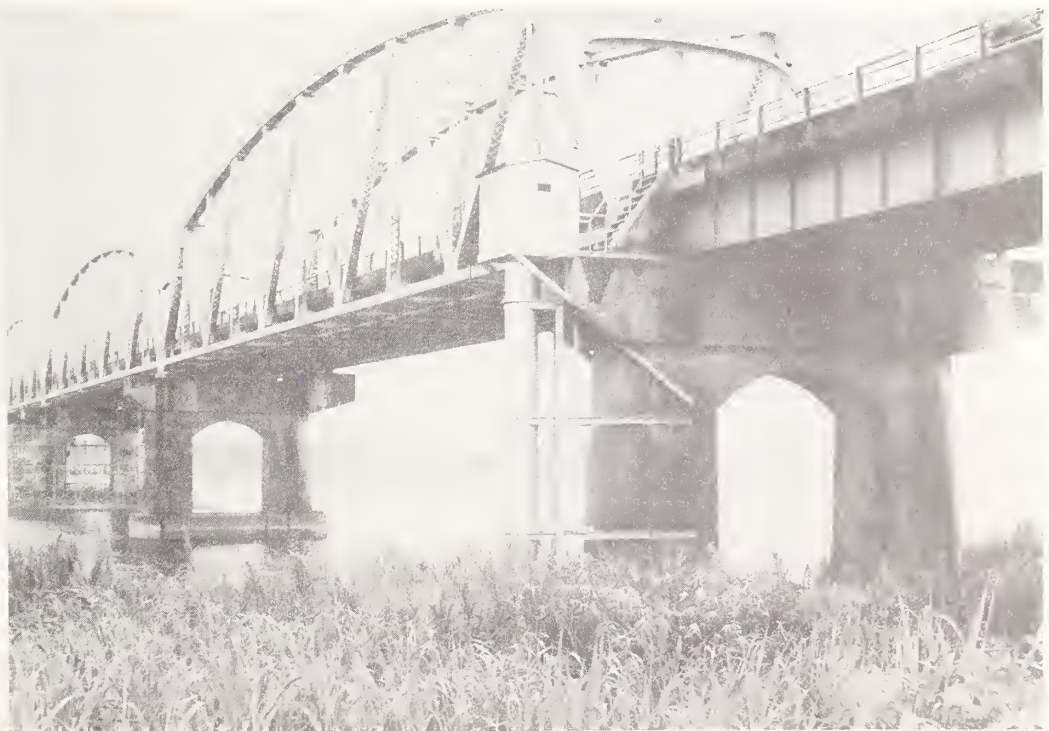
Figure 7.28 General view of the Abukuma Bridge. Note the trace of pier cracking on the pier in the foreground and scaffolding at and surface preparation of the pier in the background.

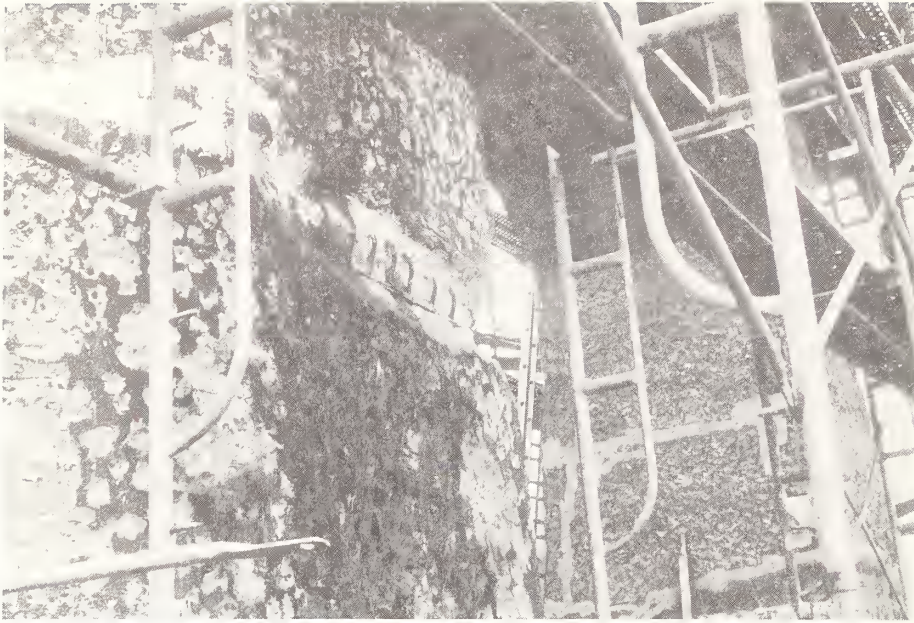
Figure 7.29 Abukuma Bridge. Outward buckling of vertical rebar at one of the damaged piers.

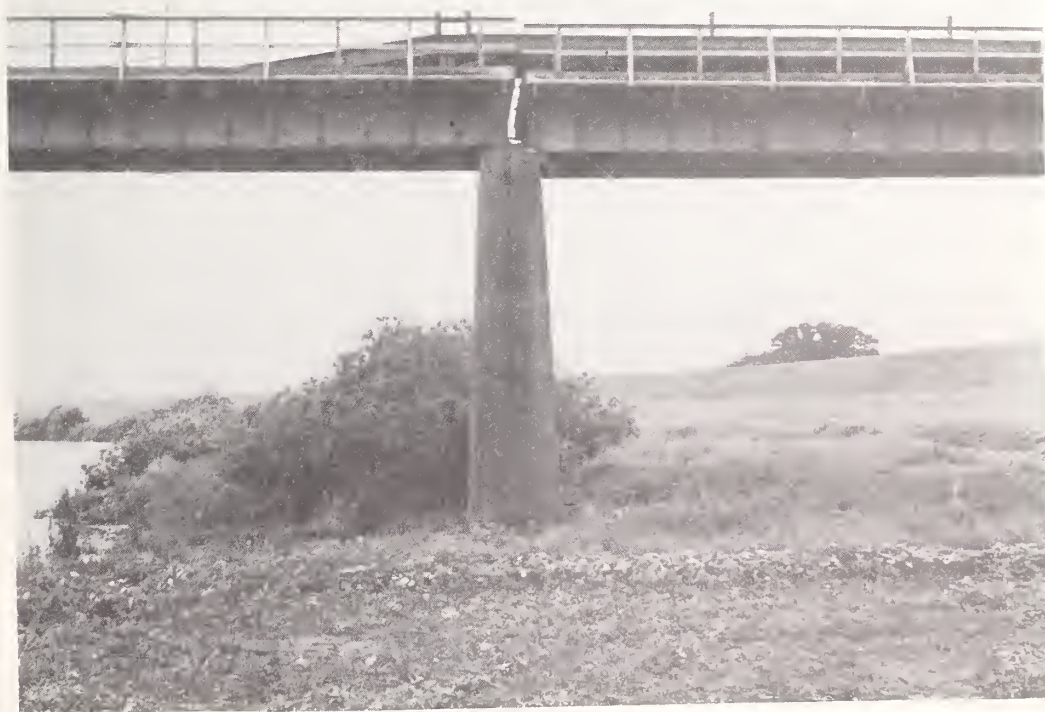
Figure 7.38 Longitudinal displacement of superstructure. Note the temporary structure which spans the dislodged main span.

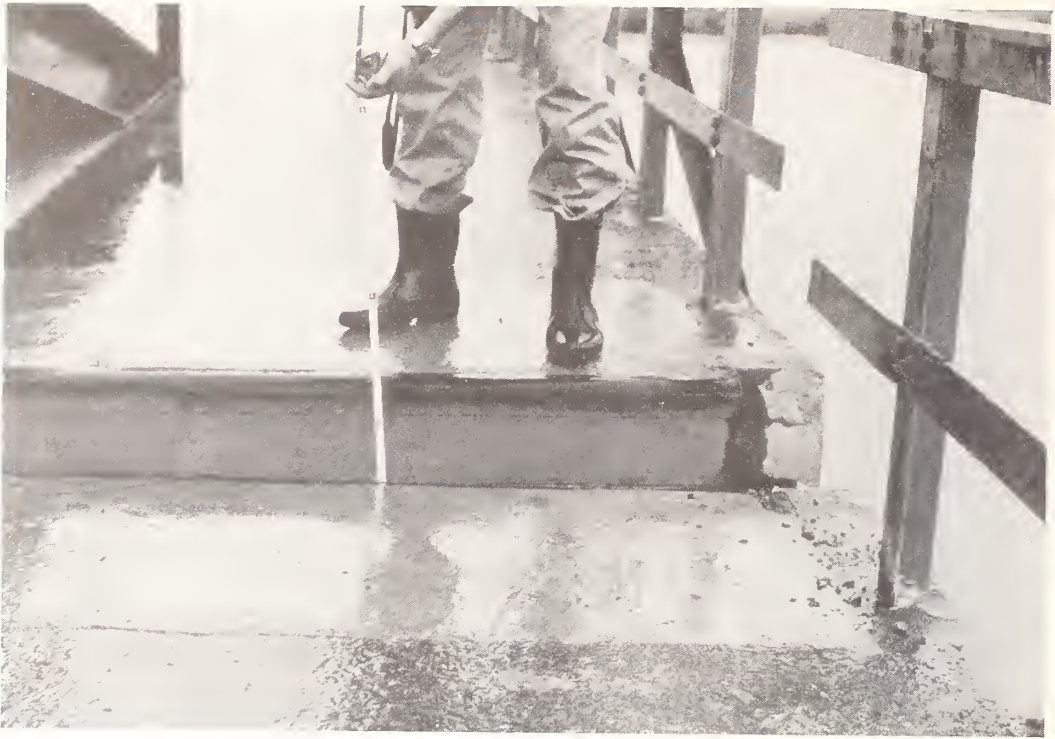
Figure 7.39 Vertical displacement of dislodged span.

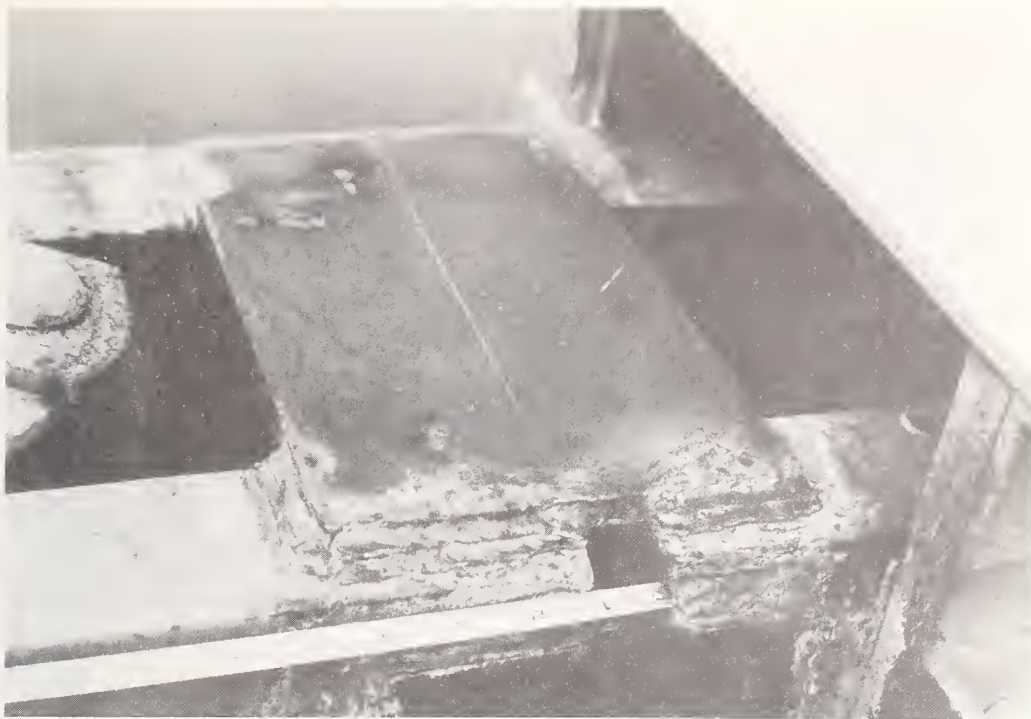
The Maiya Ohashi Bridge, Figure 7.40, is a three-span Gerber-truss bridge located on National Highway Route 342 approximately 62 km northeast of Sendai. The 181 meter long truss bridge, constructed in 1928, was closed to traffic because of a brittle fracture through the rivet holes of the top chord channel members at the first pier, Figure 7.41. Four steel plates had been welded around the top chord members. Some of the small steel angle top lateral bracing members were buckled in the vicinity of the pier, Figure 7.42. No damage was reported to either of the piers or abutments. The Maiya Bridge is scheduled to be replaced.

Figure 7.41 Maiya Ohashi Bridge. Steel plates welded to the top chord channel members. Note the clean fracture at a line passing through the centerline of the rivet holes of the lattice bracing and the permanent 2.5 cm separation.

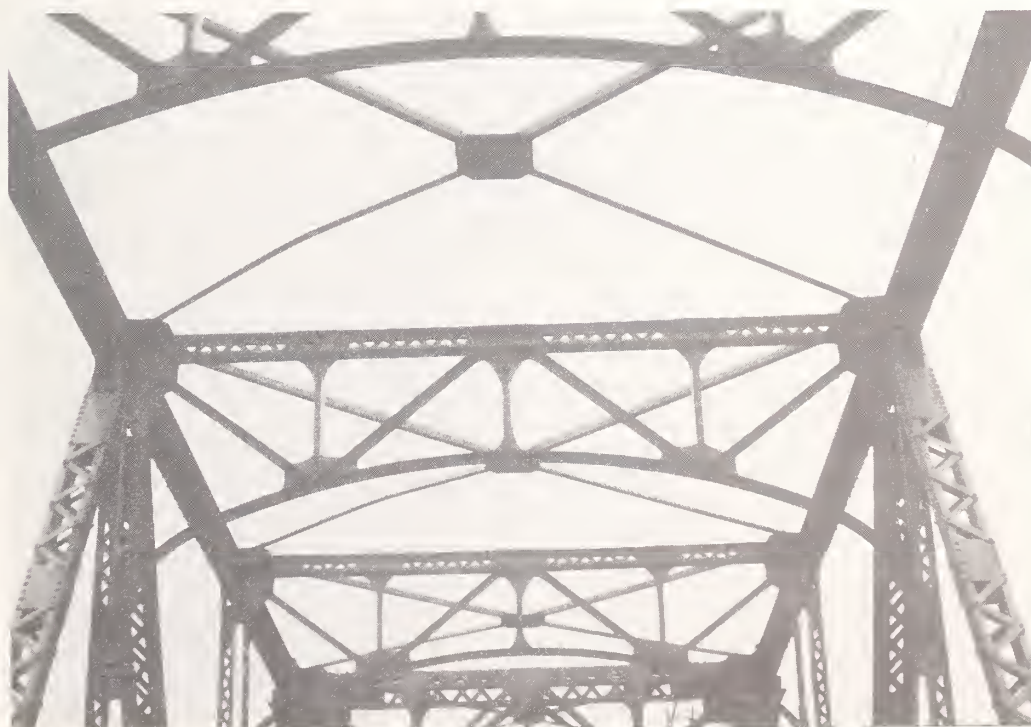
Figure 7.42 Maiya Ohashi Bridge. Buckled lateral bracing of the overhead truss.

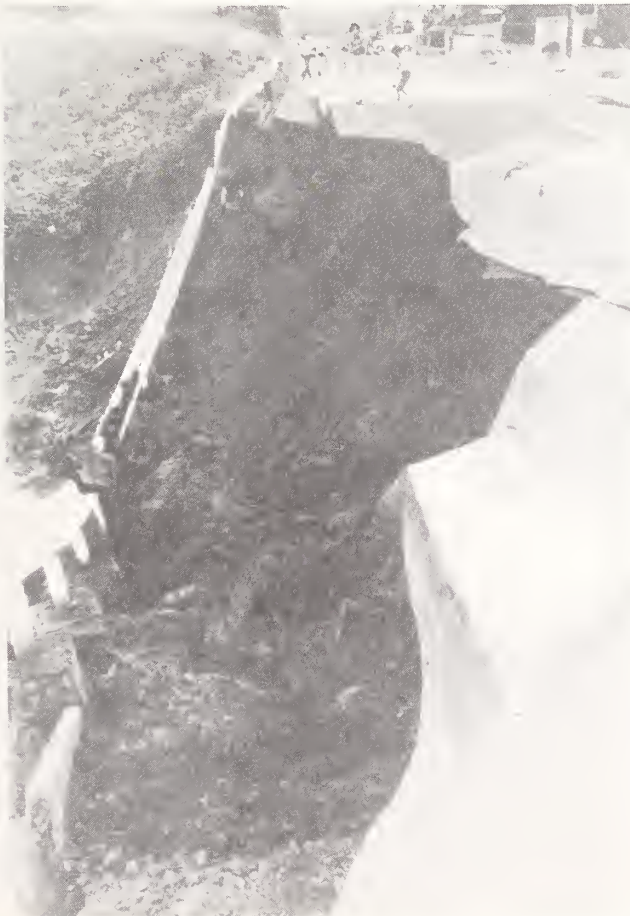
Widespread highway damage (e.g., Figure 7.44) occurred in the region north and east of Sendai. Typical damage included settlement of bridge approaches, cracking of pavements, failure of roadway embankments, and blockage of roads from rockslides. This type of damage has been documented in reports on previous large earthquakes in Alaska, Japan, California, and Guatemala and is virtually impossible to design against.

Figure 7.44 Typical Road Fill Failure.

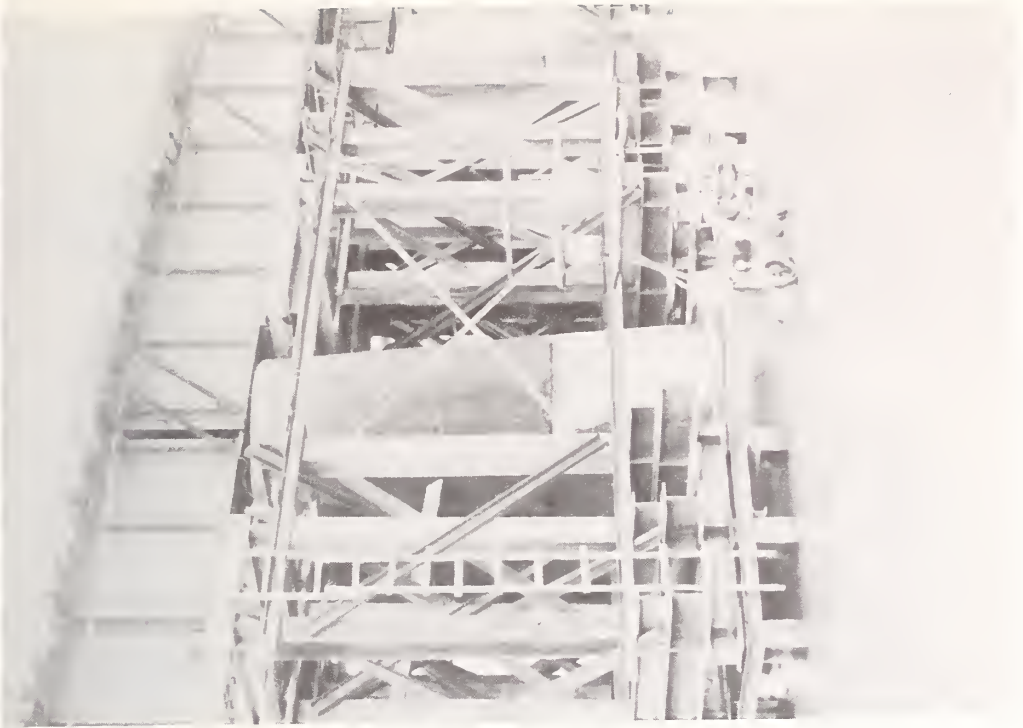
Eai River Bridge. Damaged pier of Eai River Rail Bridge. Temporary pier supports were constructed following the earthquake. Full train service was established approximately 10 days after the earthquake.

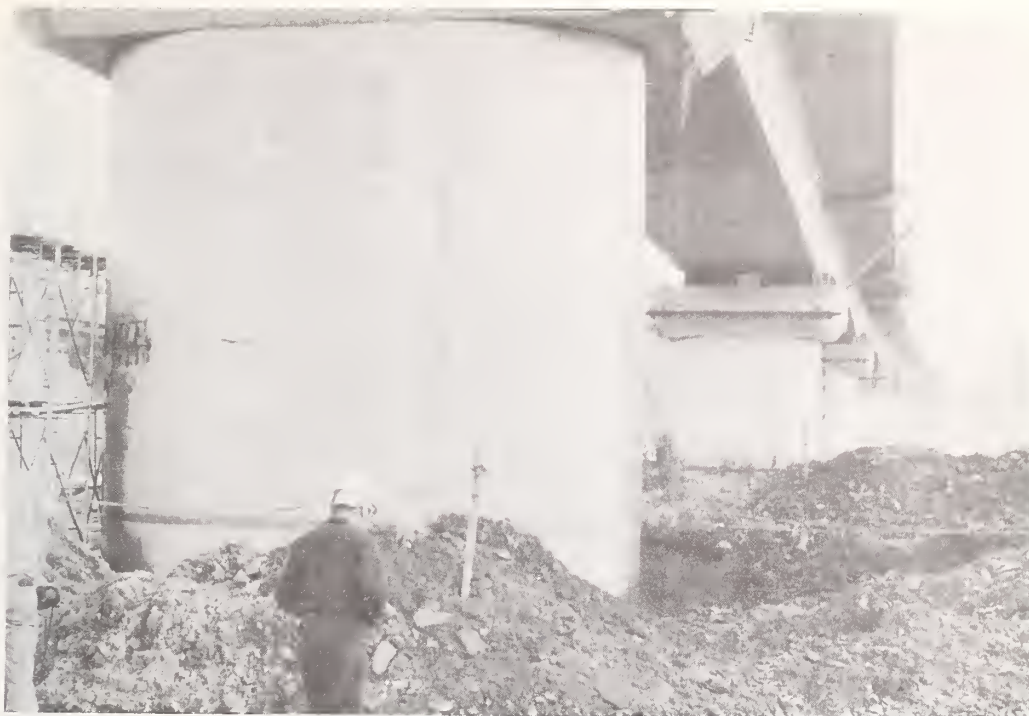
Figure 7.49 The Natori River Bridge is a three-span continuous single cell reinforced cast-in-place concrete box girder structure on 3 m x 6 m piers approximately 8 meters above grade. Typical damage included cracking in the central part of the pier where the gross cross-sectional area of vertical steel was reduced.

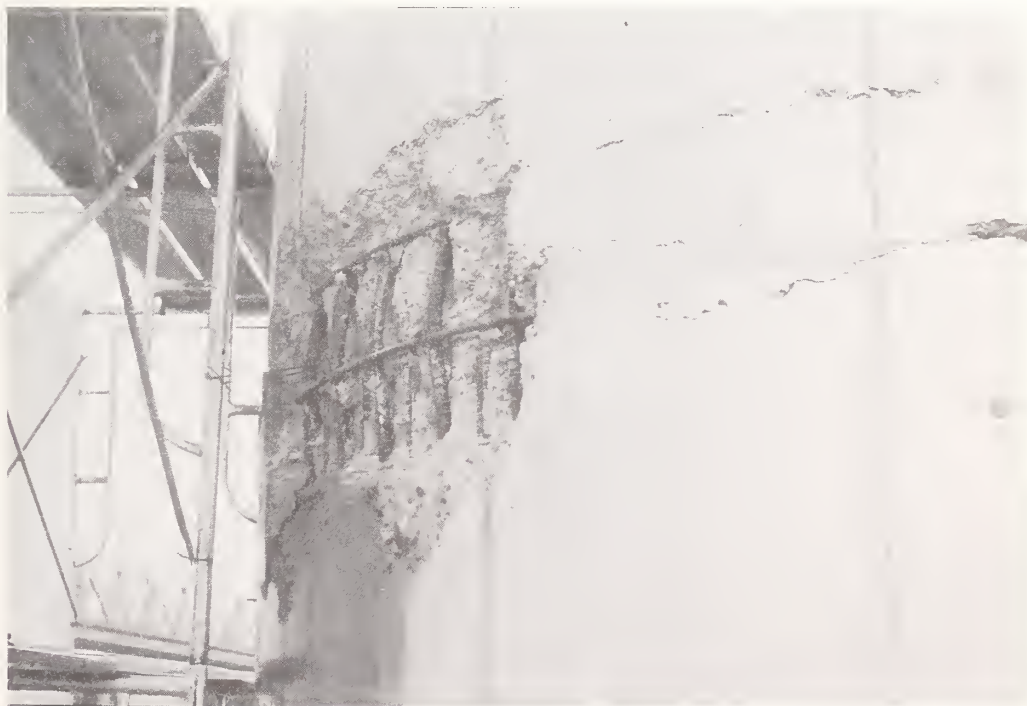
Figure 7.50 Natori River Bridge. Detail of spalled concrete at the Natori River Bridge site showing the buckled vertical rebar.

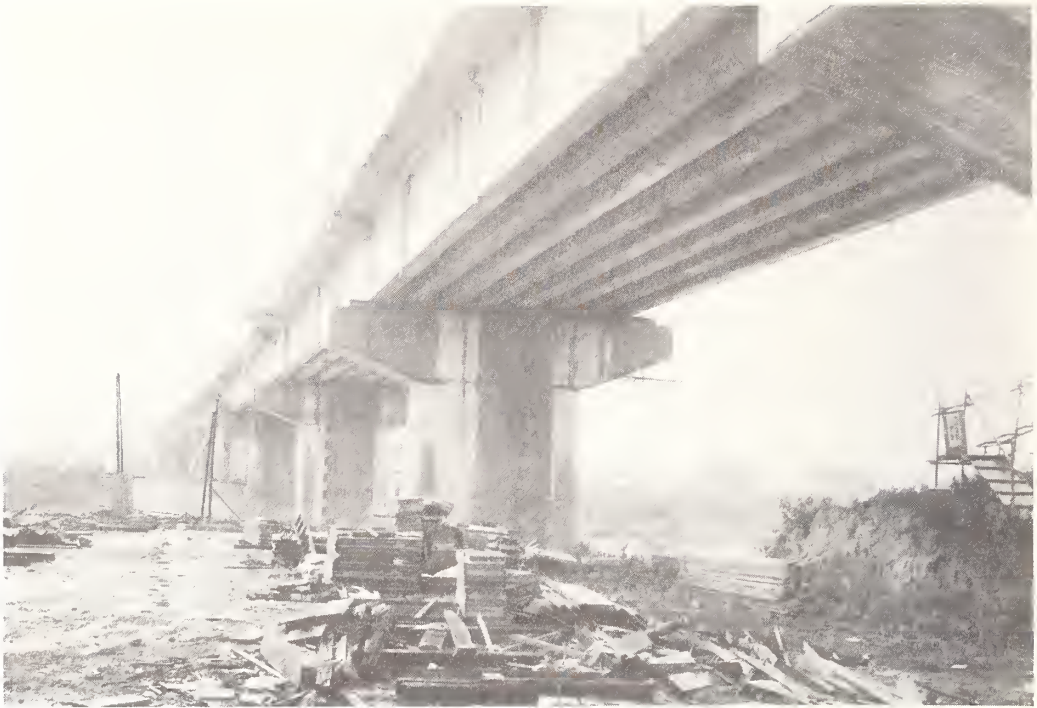
Figure 7.51 Typical structures which experienced pier cracking near the Rifu Construction Office of the Sendai Shinkansen Construction Bureau, JNR.

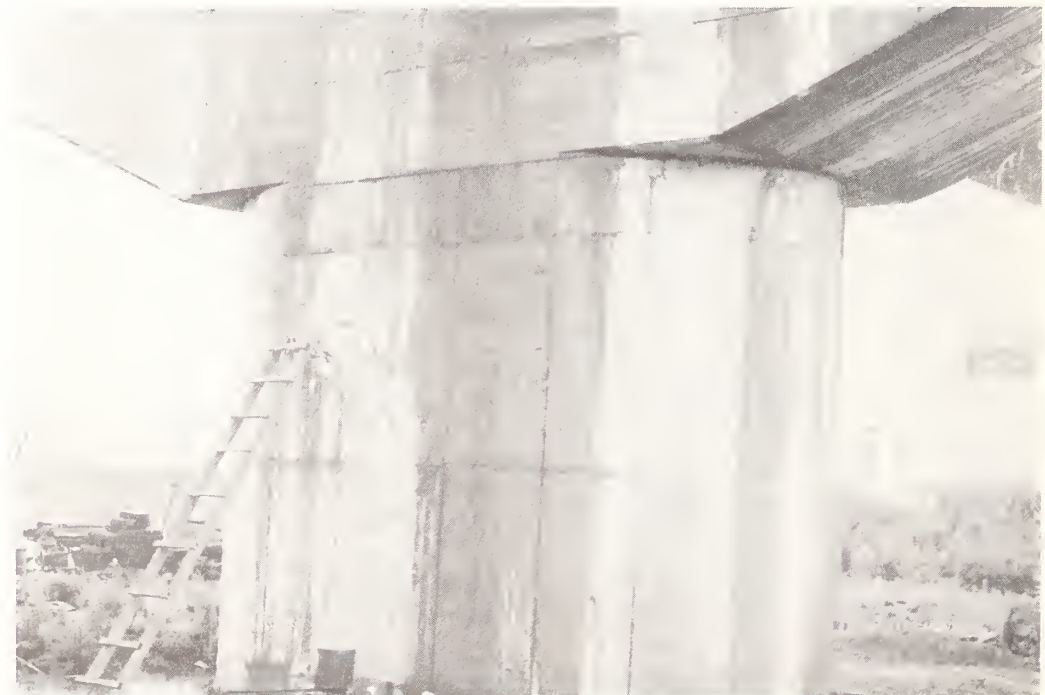
Figure 7.52 Shear cracking in the relatively lightly reinforced upper portion of the pier.

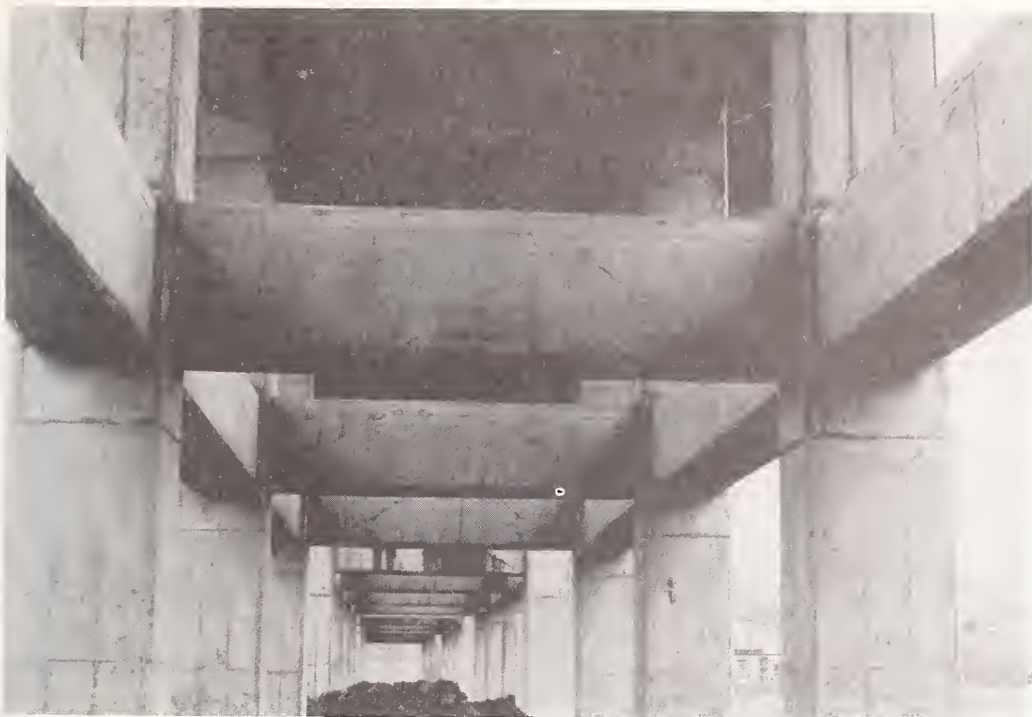
Figure 7.53 Tensile cracking of space frame tie beams near the Rifu Construction Office.

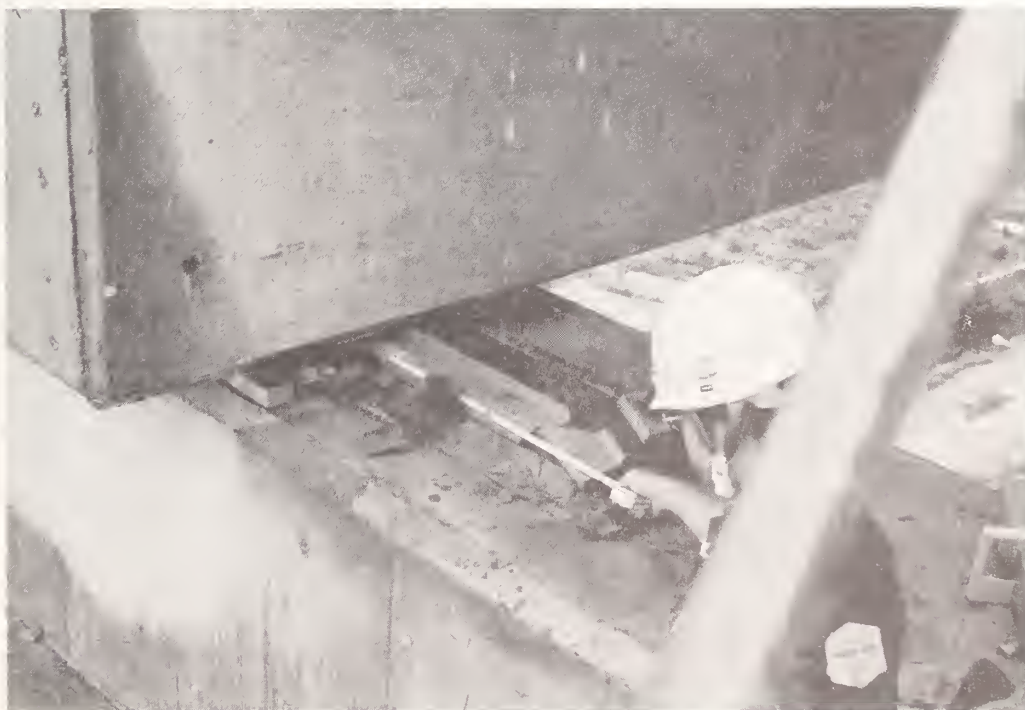
Figure 7.54 Failure of a bearing plate supporting a single cell box girder near the Higashi Sendai Construction Office. Girder displaced laterally 50 cm.

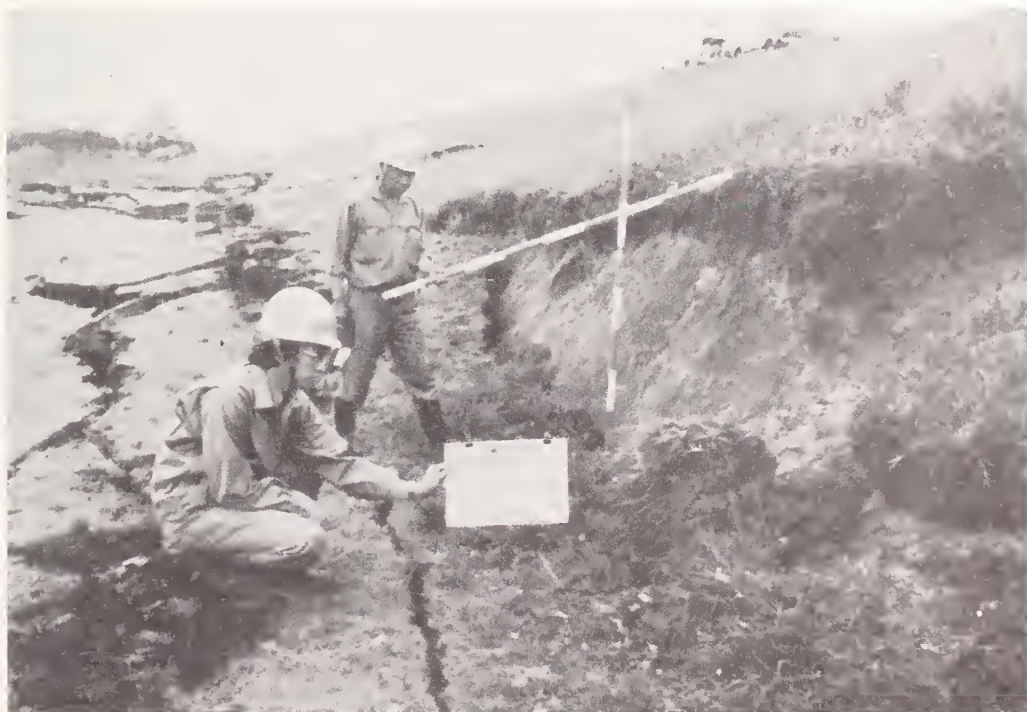
Figure 8.4 Site 1, Natori River--cracking, settlement, slumping, and lateral spreading induced by liquefaction. (From Tohoku Regional Construction Bureau, MOC, unpublished data)

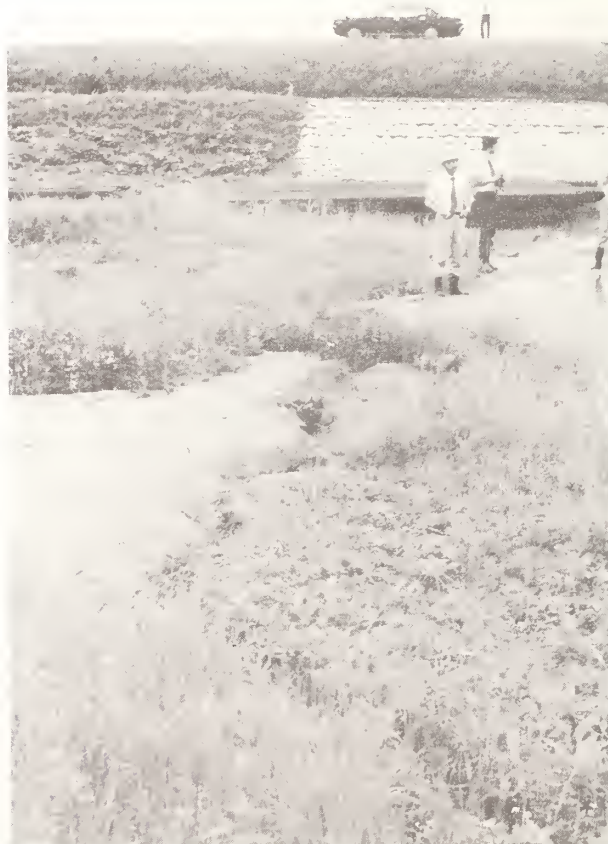
Figure 8.6 Site 2, Natori River. View is west along repaired portion of dike. Note patch across offset in retaining wall offset caused by lateral spreading during earthquake. Retaining wall rises approximately 1 m above roadway.

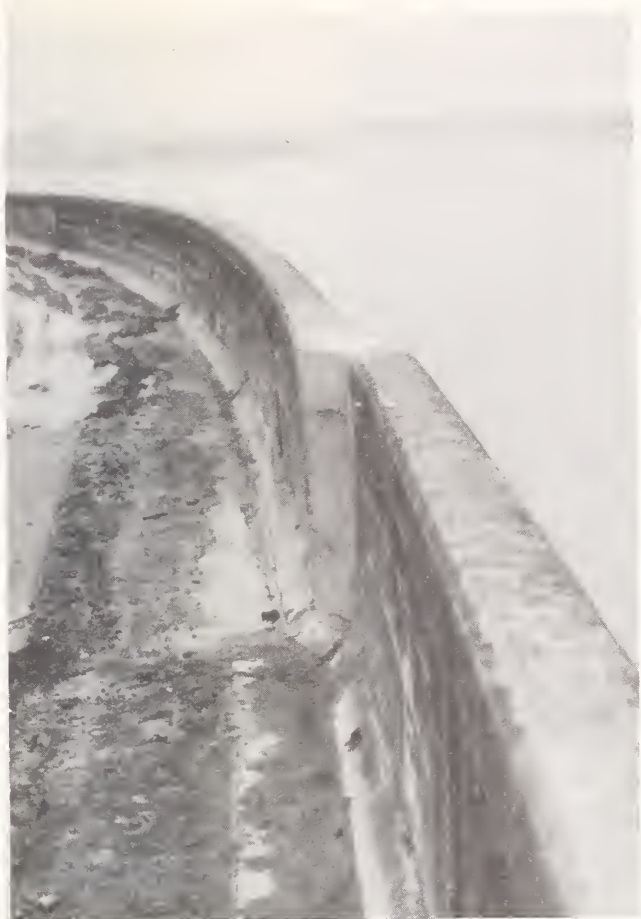
Figure 8.7 Site 2, Natori River. Settlement, lateral spreading, and longitudinal cracking of dike. View is east.  
(Photo courtesy Tohoku Regional Construction Bureau)

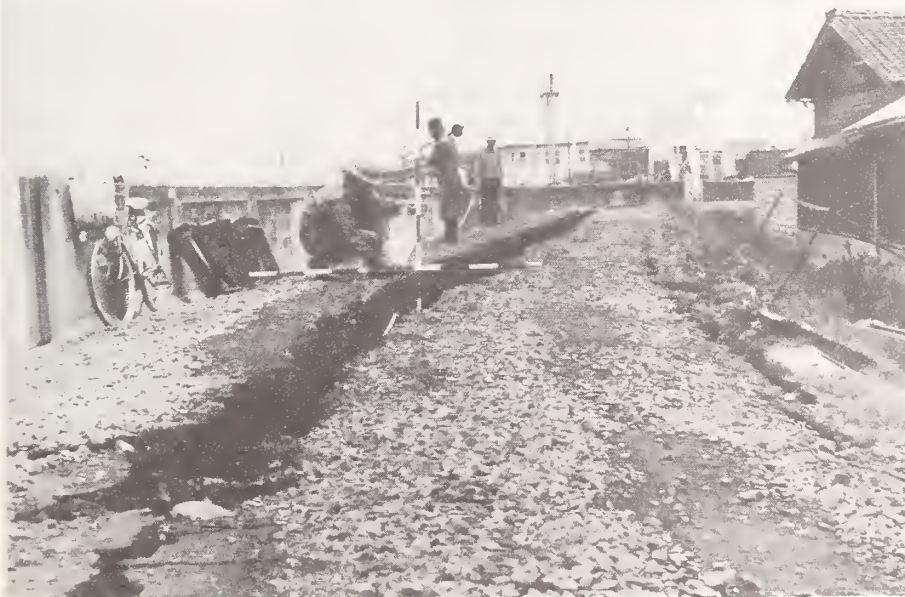
Figure 8.8 Site 2, Natori River. View is west across tributary of Natori River. Dike section shown in Figs. 8.6 and 8.7 is to right of houses in background of this figure. Note crack in concrete pavement in foreground is aligned with crack in retaining wall in background.
